TREASURE

D3.2: Report on disassemblability analysis

30/04/2022 (M11)

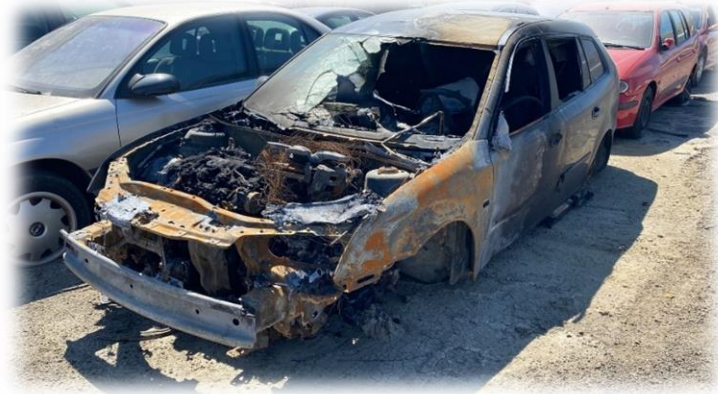
A vehicle that caught fire

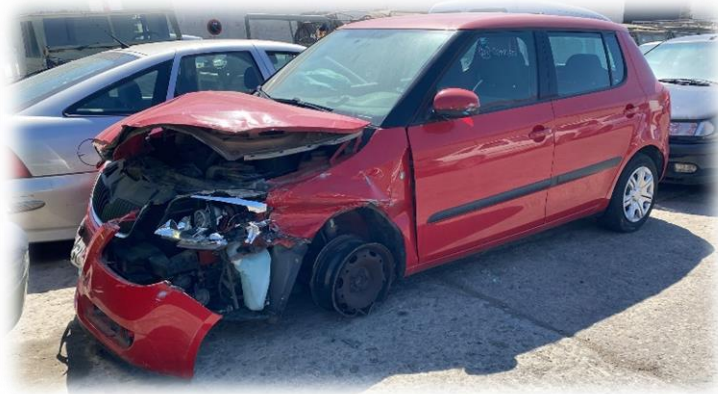
A vehicle that had a frontal accident

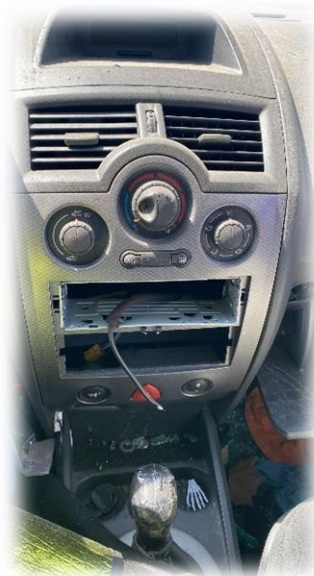
Figure 1: Examples of the ELV states when they come from accidents

A vehicle that arrived at an ELV authorised centre without the infotainment

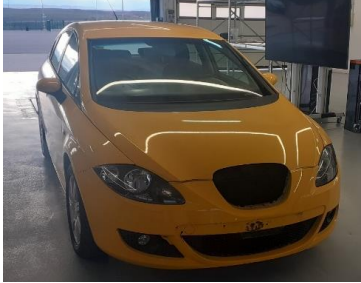
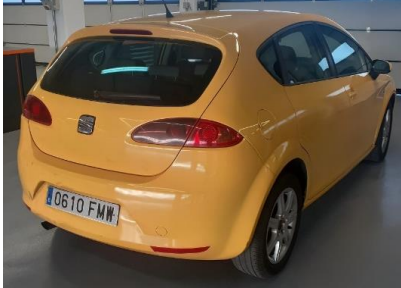
SEAT Leon model II

Plate number	VIN number
0610FMW	VSSZZZ1PZ7RD78528
SEAT Leon model III

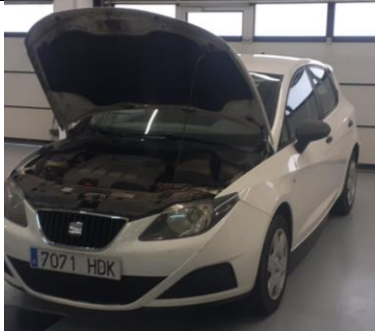
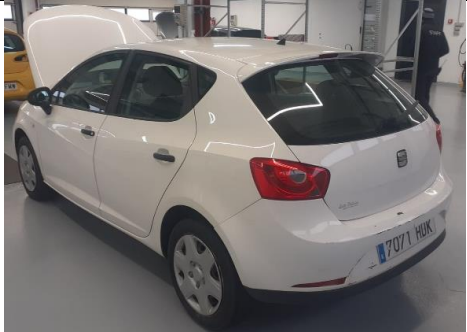
Plate number	VIN number
7071HDK	VSSZZZ6JZBR104727

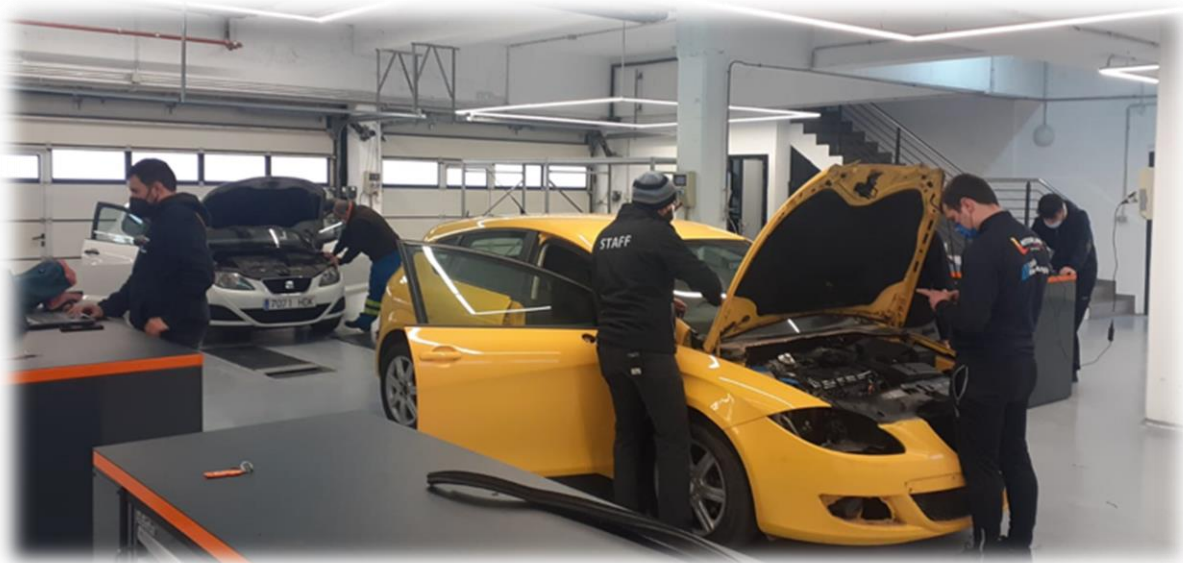
Figure 3: Facilities used in Task 3.2

- 4 x 2 m kitted workbenches (273 piece tools sets).
- Solid and liquid residue discharge modules.
- DT3600 scissor car lift.
- Sicam SBM 135L wheel balancing machine.
- Sicam Evo 628 SV1 tyre changer.
- LED lights throughout the entire workspace.
- Air compressor – 7 bar.

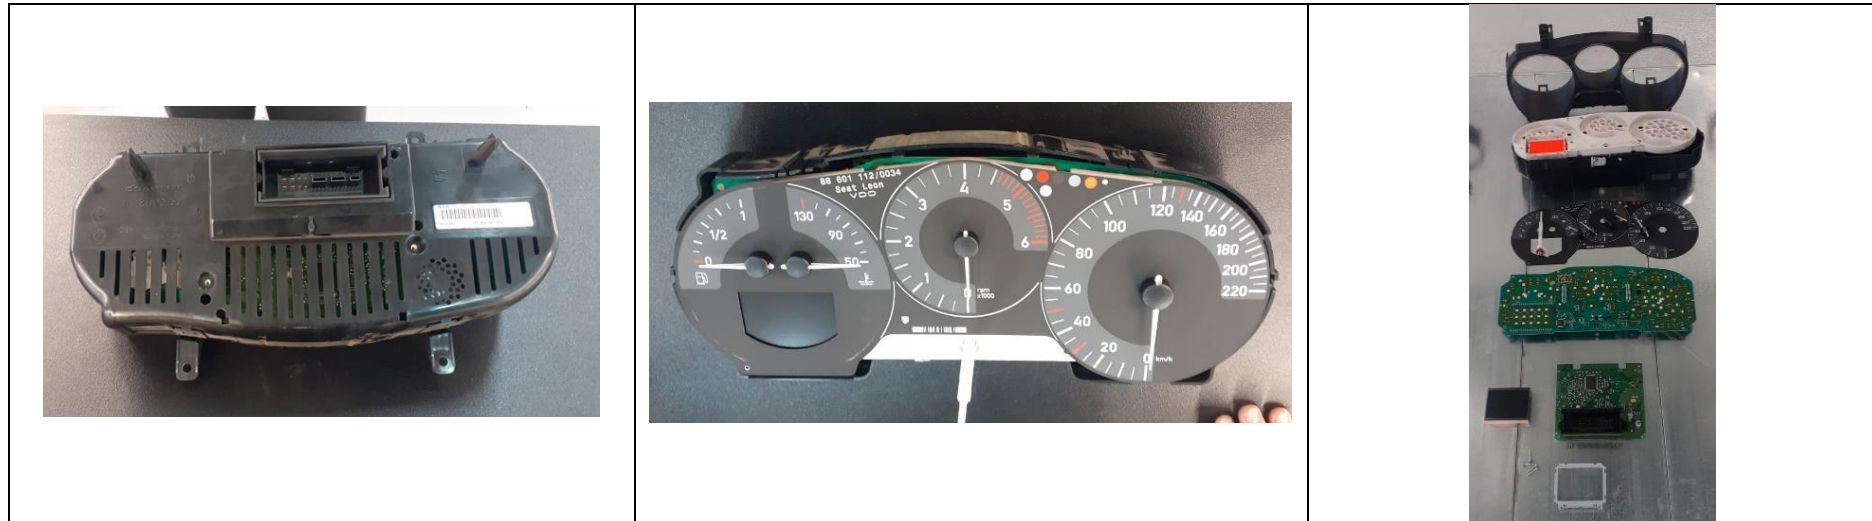
Figure 5: Combi Instrument level 2 disassembly process – SEAT Leon model II

Description	
Average time in real case	< 5 minutes
Difficulty level	High/Medium/Low
Required tools	Conventional: torx and flat screwdriver.
Process description	The first step is to remove the torx screws that join the combi instrument's main body. Subsequently, plastic cases can be separated. Afterwards the indicators can be unclipped, and finally, the different parts are separated.

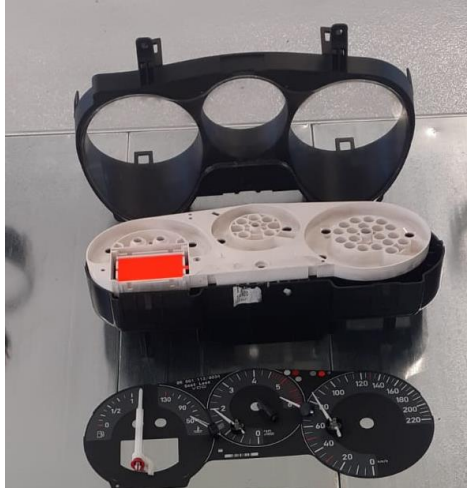
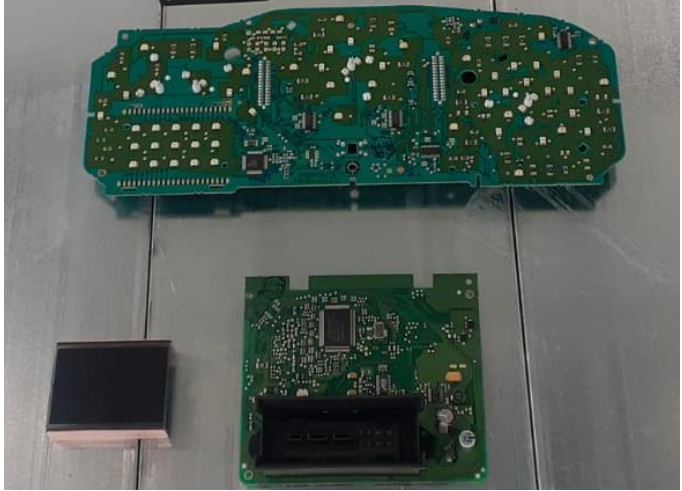
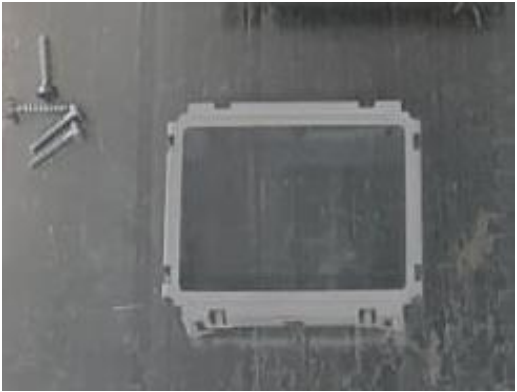
Figure 6: Combi Instrument level 3 disassembly process – SEAT Leon model II

Plastics	Non-ferrous metals-excluding Al	Ferrous metals

The three fractions obtained are: 1) the cases which are made of plastics; 2) the electronics which mainly contains non-ferrous metals (excluding Al); and 3) the display structure which is made of ferrous metals.

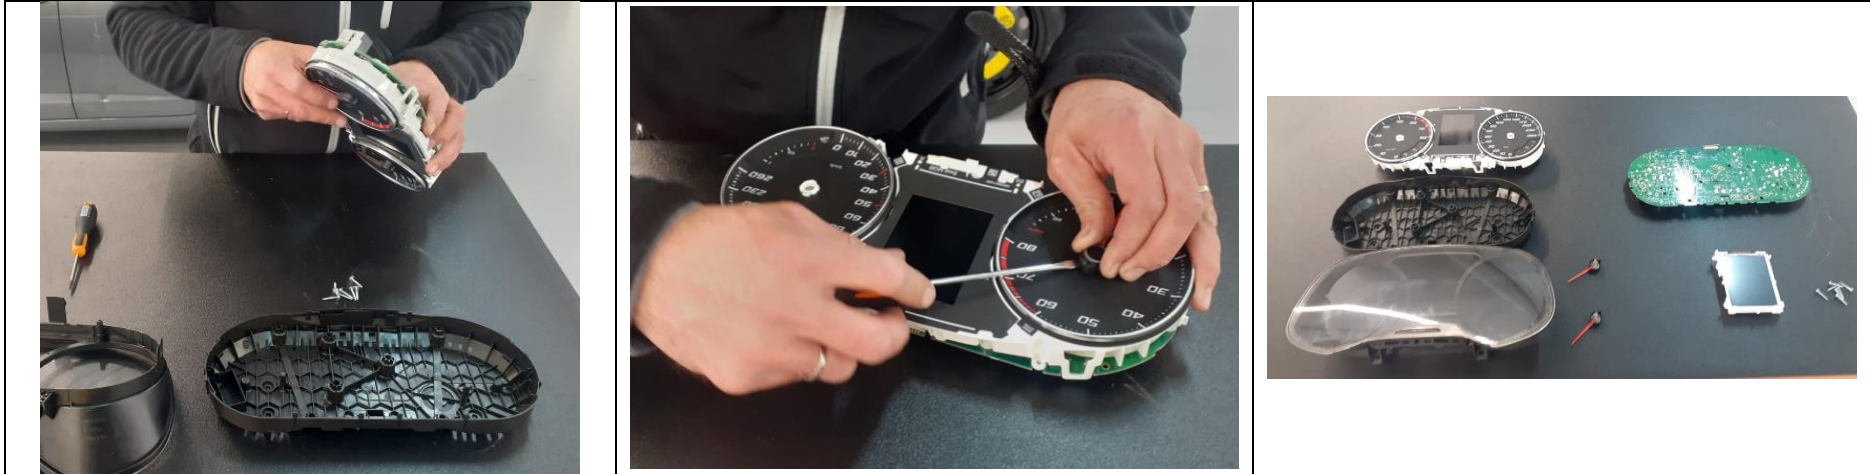
Figure 8: Combi Instrument level 2 disassembly process – SEAT Leon model III

Description	
Average time in real case	< 5 minutes
Difficulty level	High/Medium/ Low
Required tools	Conventional: torx and flat screwdriver.
Process description	The first step is to remove the torx screws that join the combi instrument. Subsequently, the plastic cases are separated. Afterwards the indicators can be unfastened, and finally, the different parts are separated.

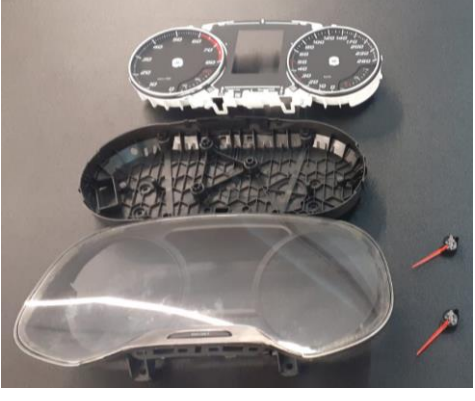
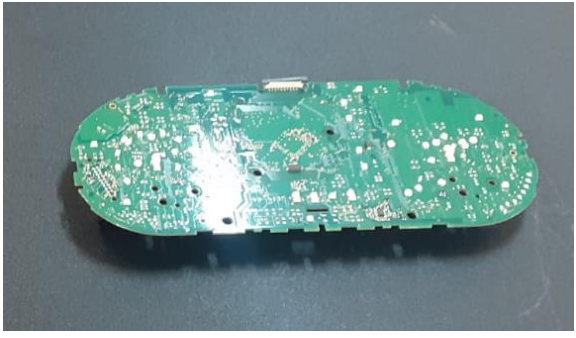
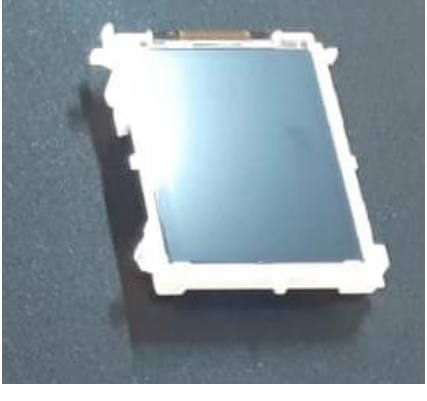
Figure 9: Combi Instrument level 3 disassembly process – SEAT Leon model III

Plastics	Non-ferrous metals-excluding Al	Non-ferrous metals-Al + Non-ferrous metals-excluding Al	Ferrous metals

The four fractions obtained are: 1) The cases which are made of plastics; 2) the electronics which mainly contains non-ferrous metals (excluding Al); 3) the display which has non-ferrous metals; and 4) the screws which are manufactured with ferrous metals.

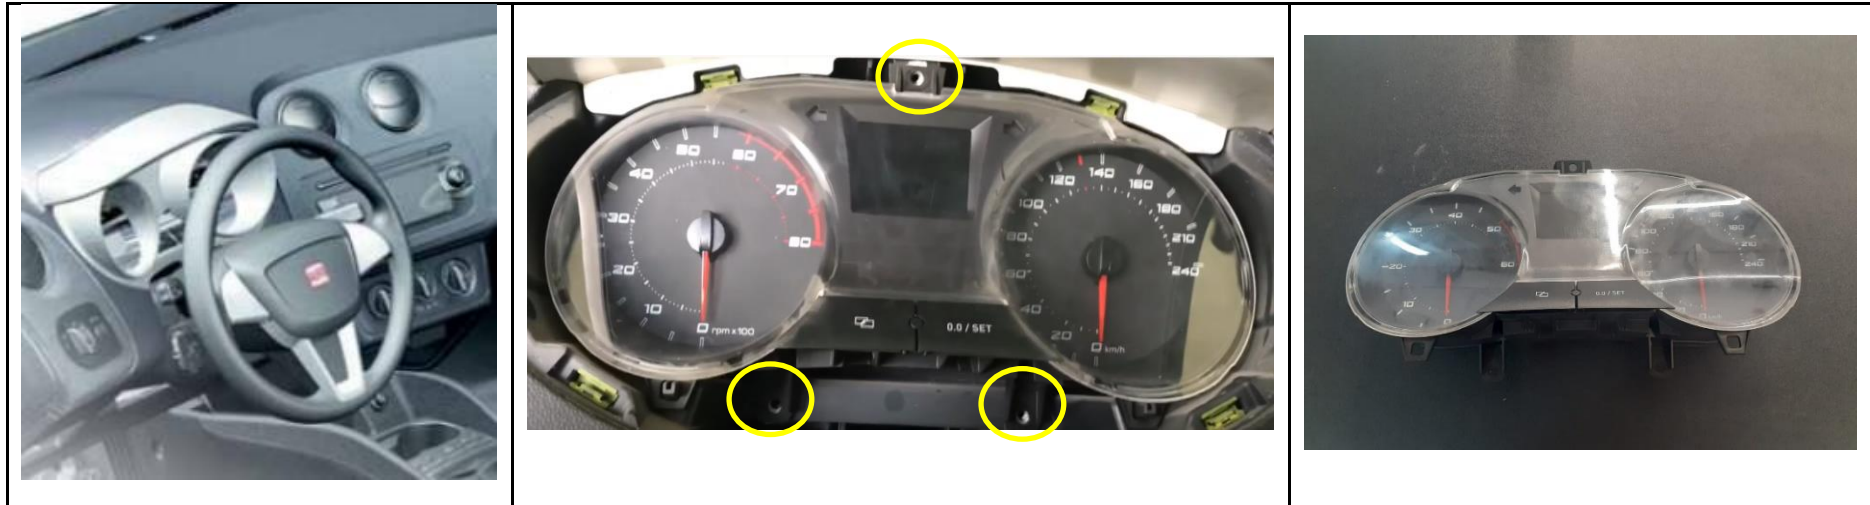
Figure 10: Combi Instrument level 1 disassembly process – SEAT Ibiza model IV

The left image shows the combi instrument location and the plastic case that covers the screws. In the central image shows when the plastic case has been removed, and the three torx screws are accessible. The image on the right shows the part extracted from the car.

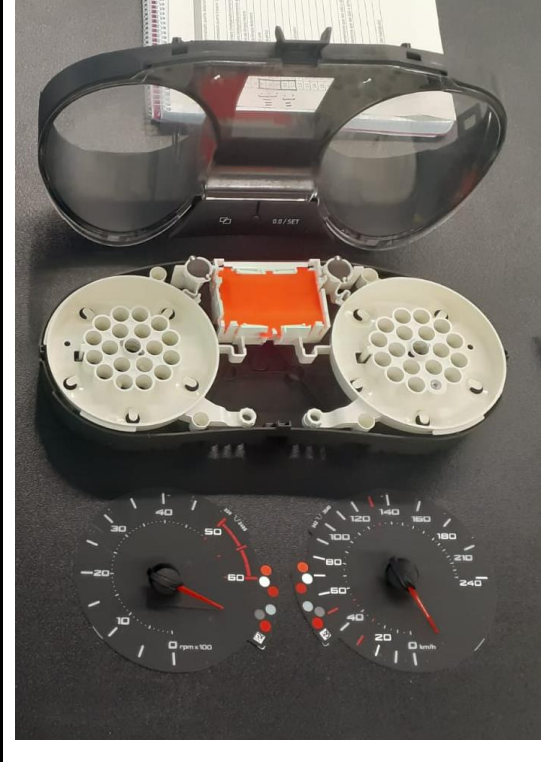
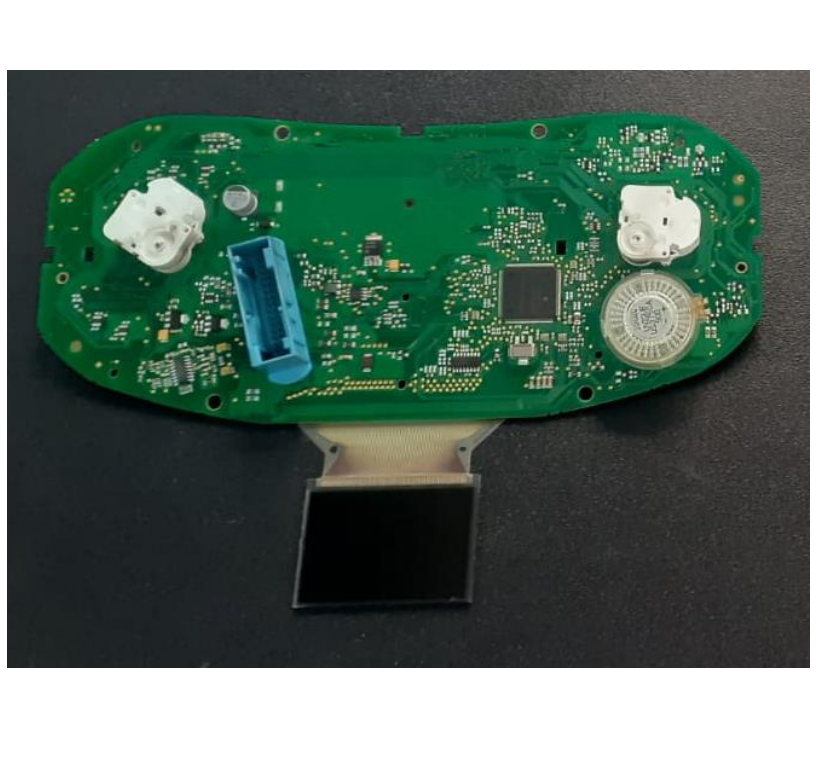
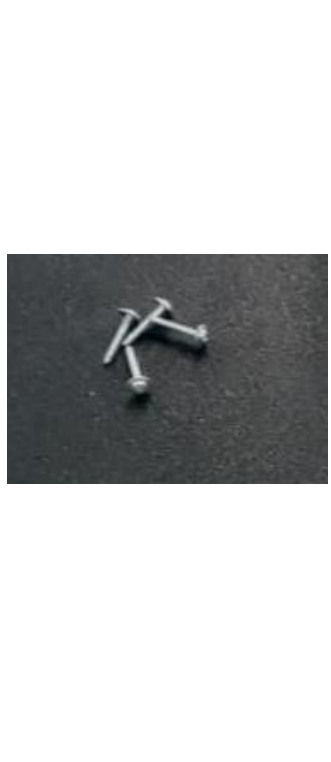
Figure 12: Combi Instrument level 3 disassembly process – SEAT Ibiza model IV

Plastics	Non-ferrous metals-excluding Al	Ferrous metals

The three fractions obtained are: 1) The cases which are made of plastics; 2) the electronics and the central display which mainly contain non-ferrous metals (excluding Al); and 3) the screws which are made of ferrous metals.

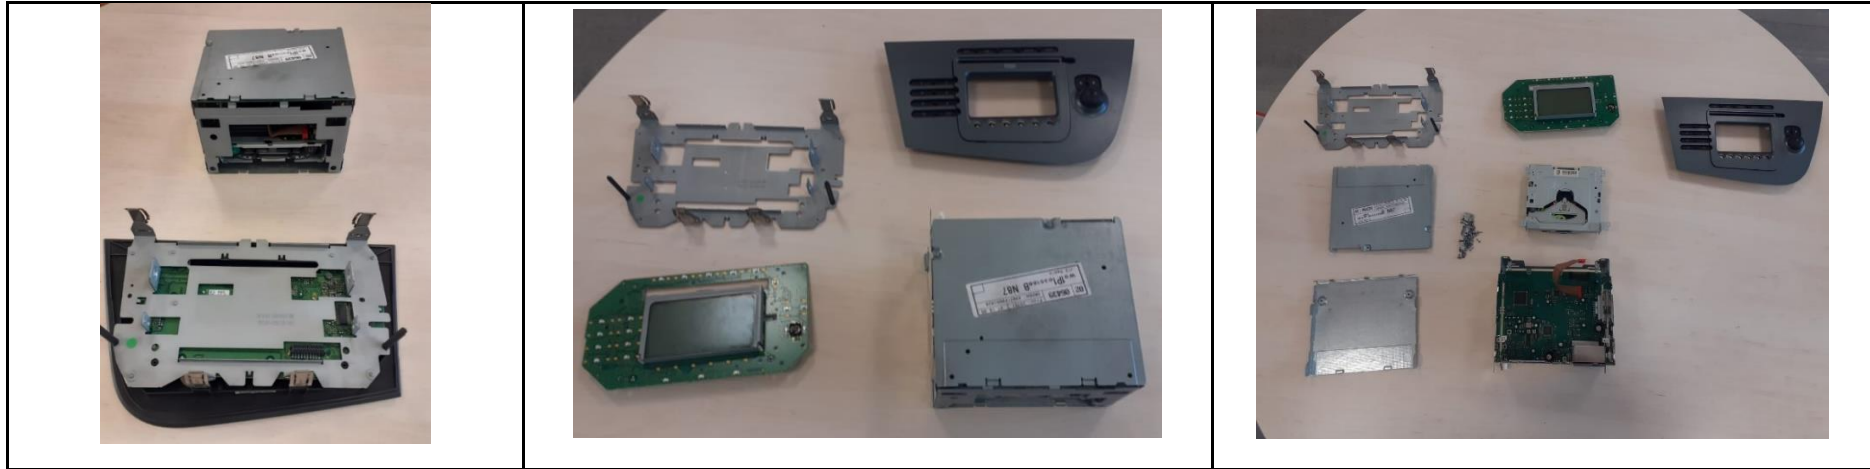
Figure 14: Infotainment level 2 disassembly process – SEAT Leon model II

Description	
Average time in real case	< 10 minutes
Difficulty level	High/Medium/ Low
Required tools	Conventional: torx
Process description	All the subparts of the main structure are joined using screws so the part can be subdisassembled into small subparts: main electronic boards, frontal cover and structure. Nevertheless, it must be highlighted that an electronic board placed in the bottom part of the main body is welded to it and, as a consequence, it cannot be separated.

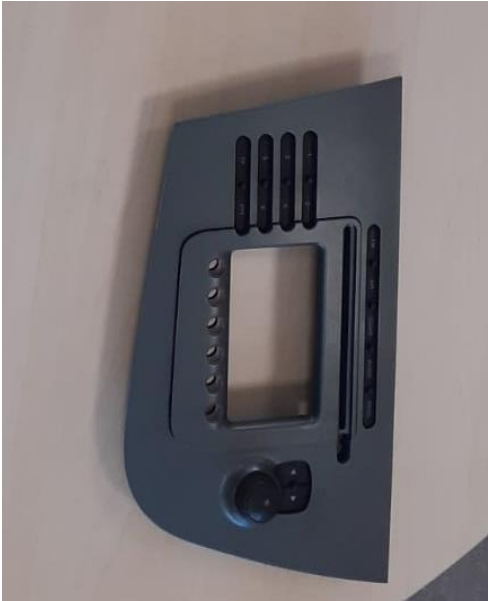
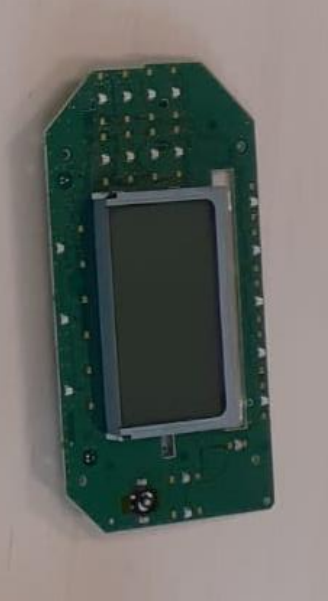
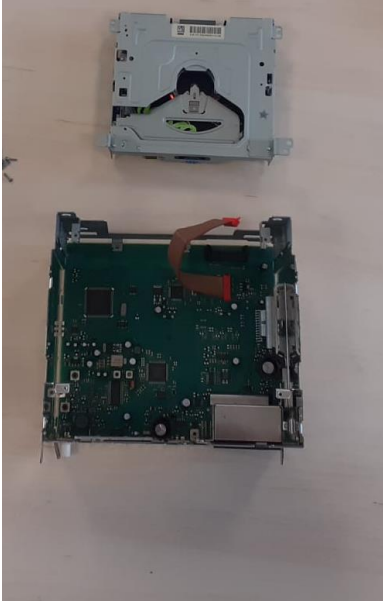
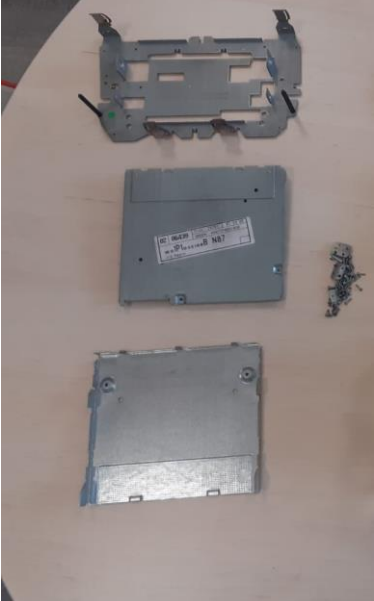
Figure 15: Infotainment level 3 disassembly process – SEAT Leon model II

Plastics	Non-ferrous metals-excluding Al	Ferrous metals – Non-ferrous metals-excluding Al	Ferrous metals

Four different fractions are obtained in this part. The cover, which is made of plastics. The electronic and the front display that are mainly built with non-ferrous metals (excluding Al). The main body with the CD reader which is mainly manufactured with ferrous and non-ferrous metals (excluding Al) and finally the metallic covers with are made of ferrous metals.

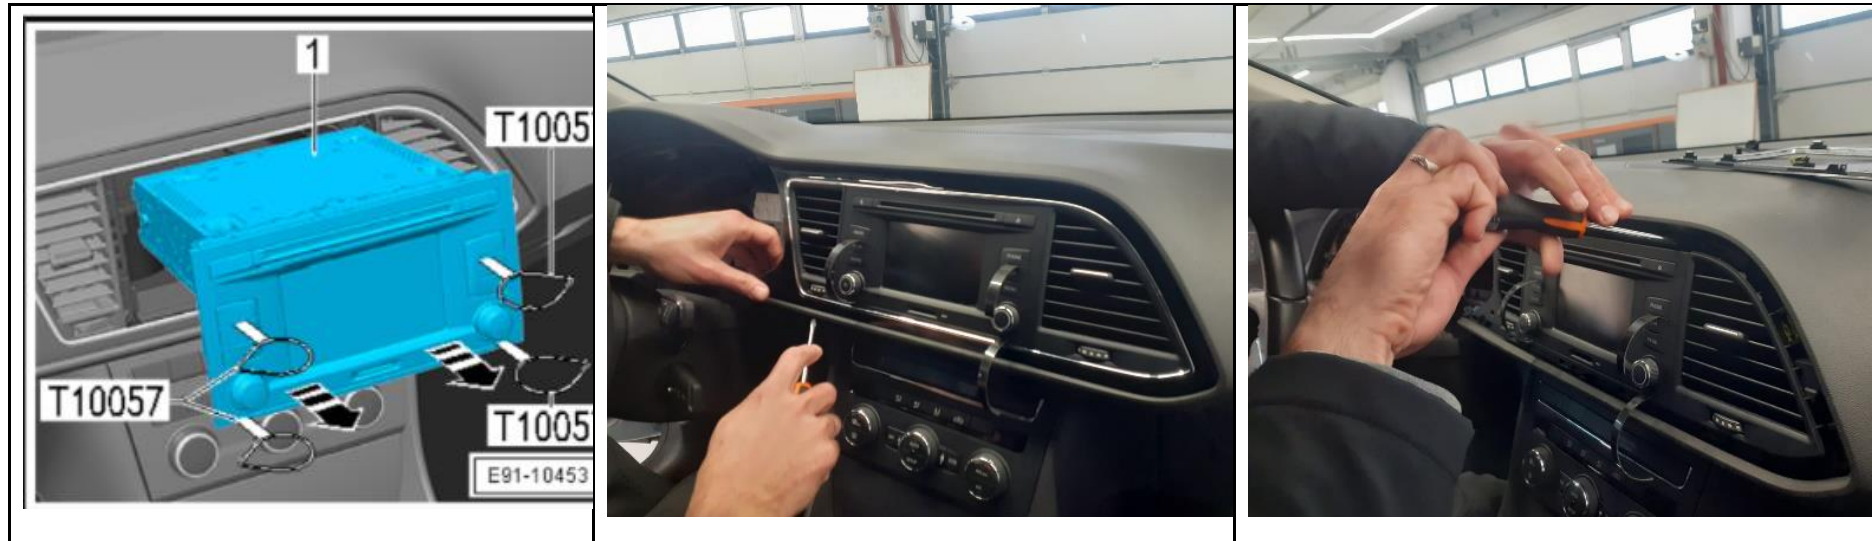
Figure 16: Infotainment level 1 disassembly process – SEAT Leon model III

The left image obtained from SEAT garage manual shows the location of the four flat tools. These tools are needed to unlock the infotainment clipping system. In our case, we manufactured four tools *ad hoc*.

- The use of non-standard tools was only required in the disassembly of infotainment units used in SEAT Leon model II and SEAT Leon model III. It is recommended to apply a system similar to the SEAT Ibiza model IV where torx screws are used.

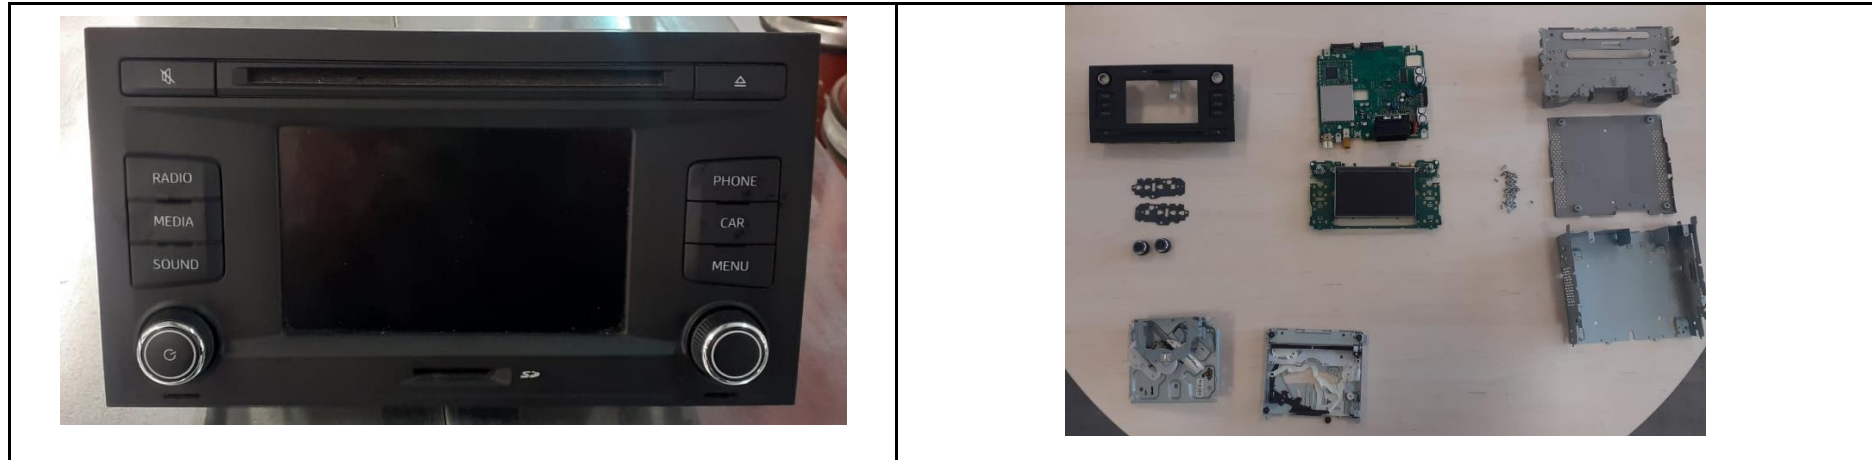
Figure 17: Infotainment level 2 disassembly process – SEAT Leon model III

Description	
Average time in real case	< 10 minutes
Difficulty level	High/Medium/ Low
Required tools	Conventional: torx
Process description	All the subparts of the main structure are joined using screws so the part can be subdisassembled into small subparts: main electronic boards, frontal cover and structure.

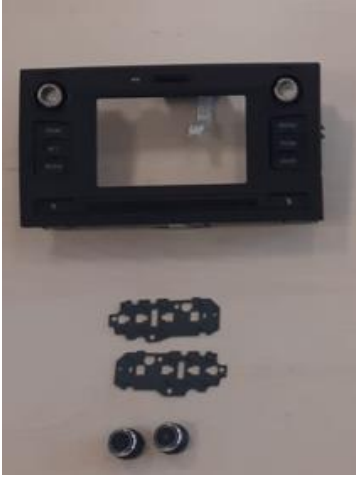
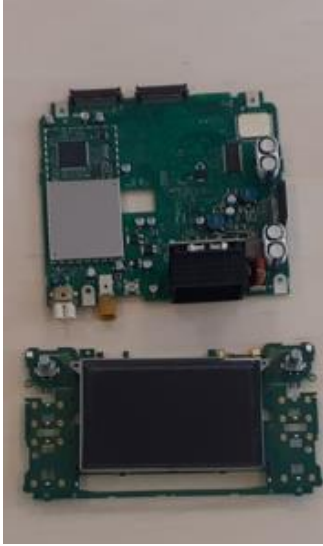
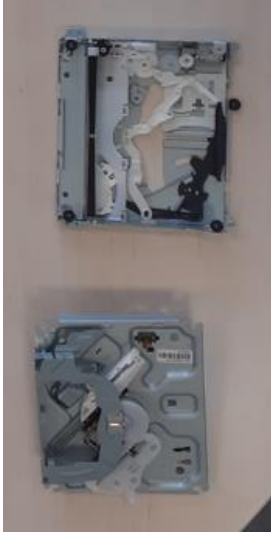
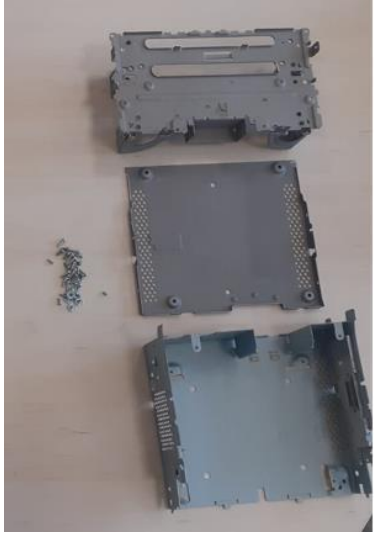
Figure 18: Infotainment level 3 disassembly process – SEAT Leon model III

Plastics	Non-ferrous metals-excluding Al	Ferrous metals – Plastics – Non-ferrous metals	Ferrous metals

Four different fractions are obtained in this part. The cover is made of plastics, the electronics which is mainly built with non-ferrous metals (excluding Al), the main body with the CD reader that is mainly manufactured with ferrous and plastics and finally, the metallic covers are made of ferrous metals.

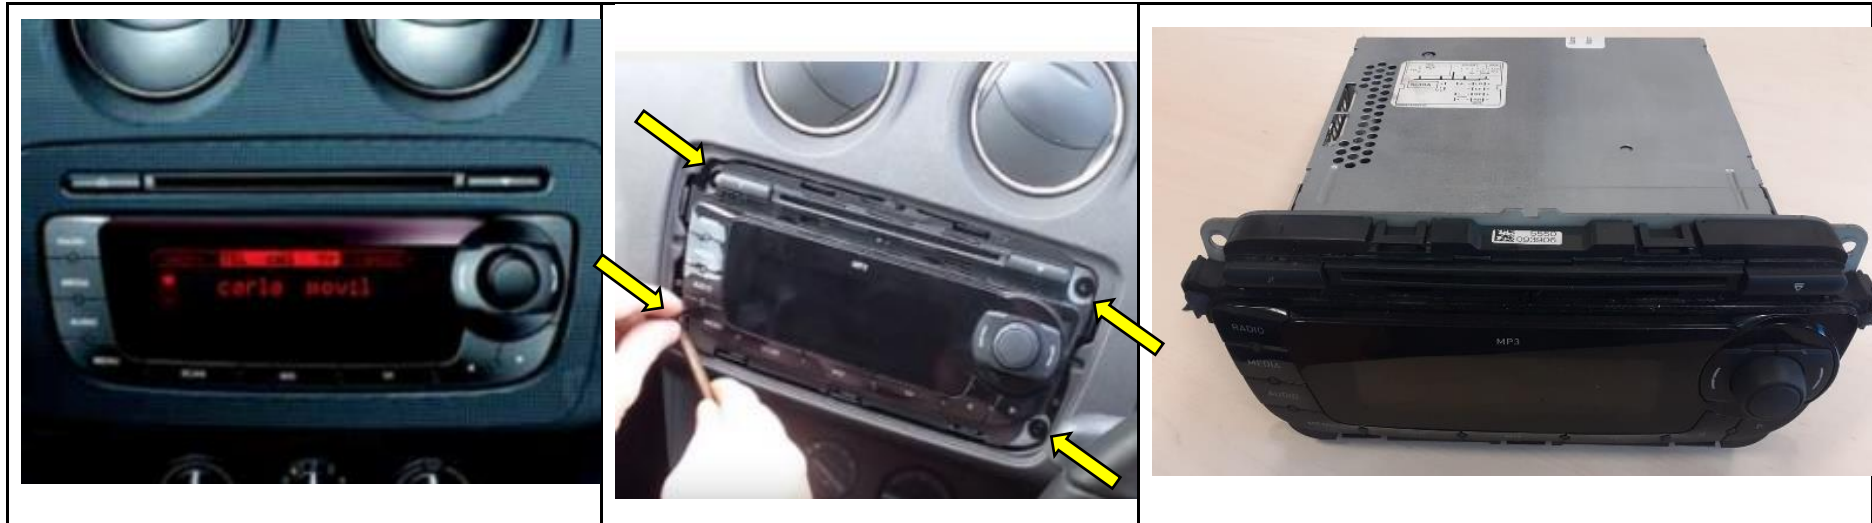
Figure 19: Infotainment level 1 disassembly process – SEAT Ibiza model IV

The image on the left shows that the infotainment is installed with the frontal cover. The image in the middle shows the infotainment without the plastic cover and the location of the four torx screws . Finally, the image on the right shows the infotainment unit out of the car.

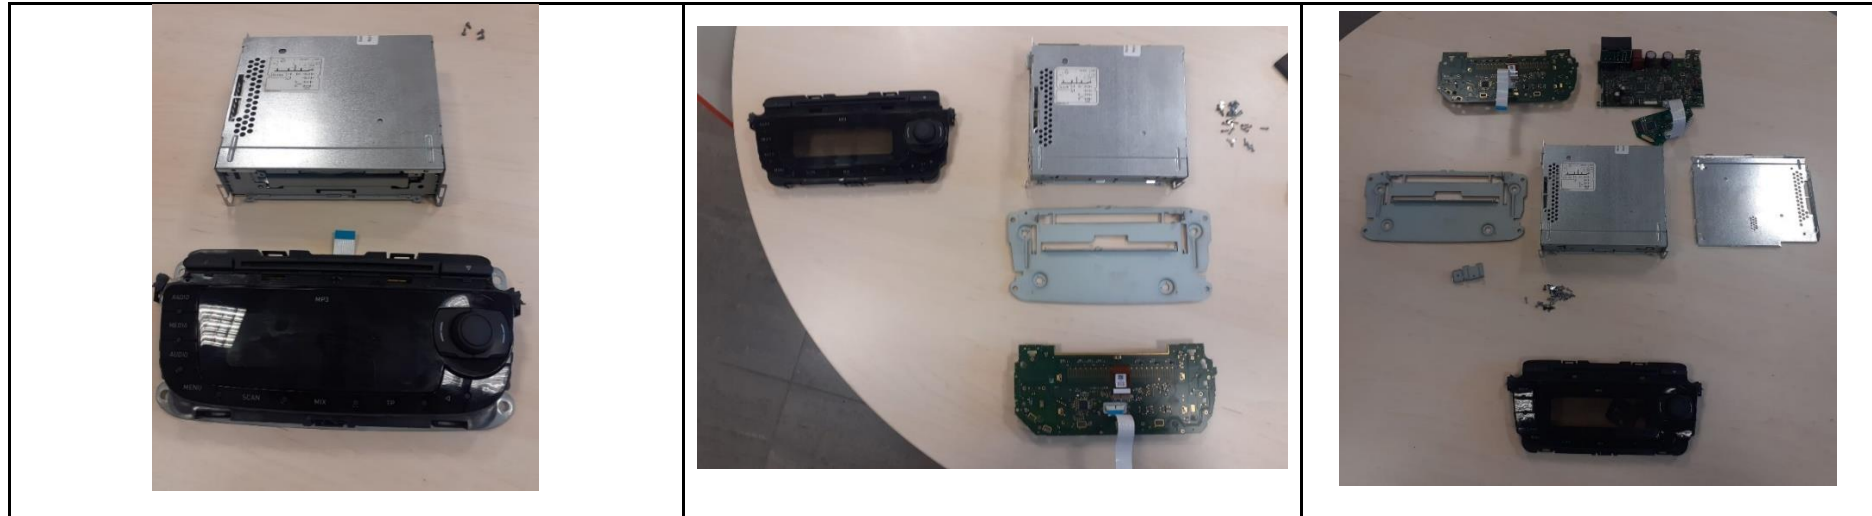
Figure 20: Infotainment level 2 disassembly process – SEAT Ibiza model IV

Description	
Average time in real case	< 10 minutes
Difficulty level	High/Medium/Low
Required tools	Conventional: torx
Process description	All the subparts of the main structure are joined using screws so the part can be subdisassembled in small subparts: main electronic boards, frontal cover and structure.

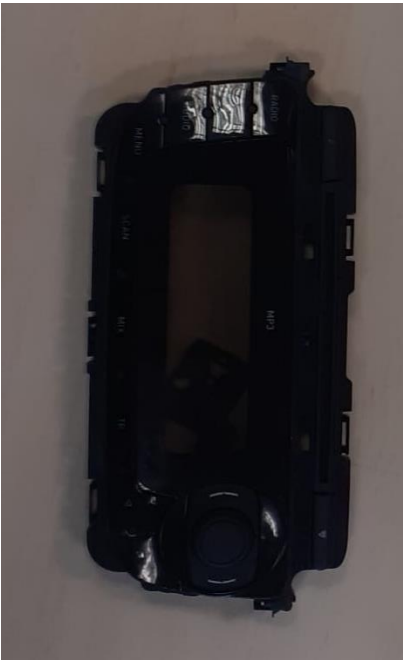
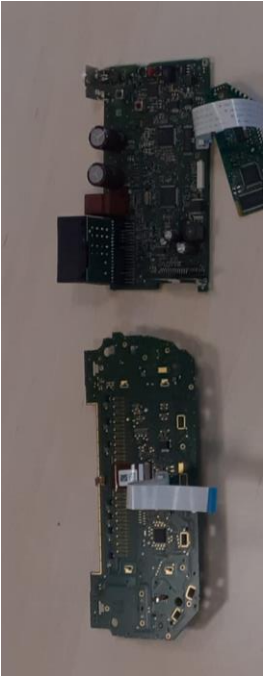
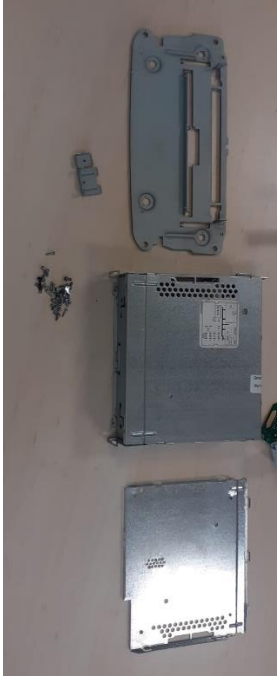
Figure 21: Infotainment level 3 disassembly process – SEAT Ibiza model IV

Plastics	Non-ferrous metals-excluding Al	Ferrous metals

Three different fractions are obtained in this part. The cover which is made of plastics, the electronics which is mainly built with non-ferrous metals (excluding Al), and the main body structure which is made of ferrous metals.

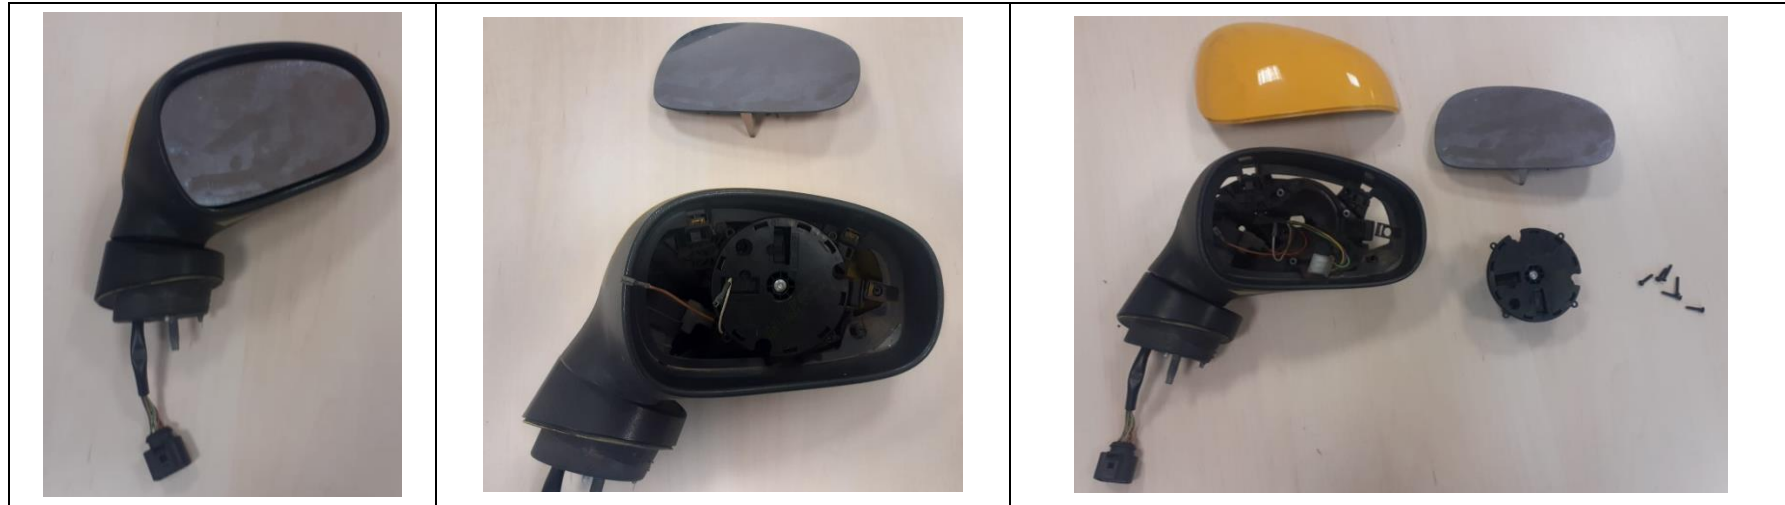
Figure 23: Exterior mirror level 2 disassembly process – SEAT Leon model II

Description	
Average time in real case	< 5 minutes
Difficulty level	High/Medium/ Low
Required tools	Conventional: torx / flate screwdriver
Process description	The first step is to remove the mirror. It can be done by pulling it out because it is clipped. Next, the front cover can be separated from the main body by clicking it out. After that the mirror engine can be unscrewed.

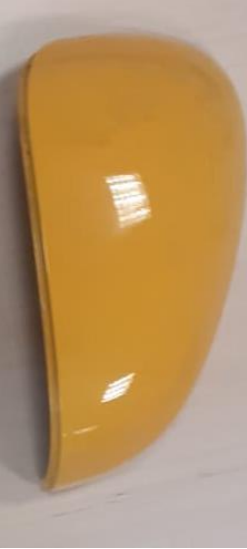
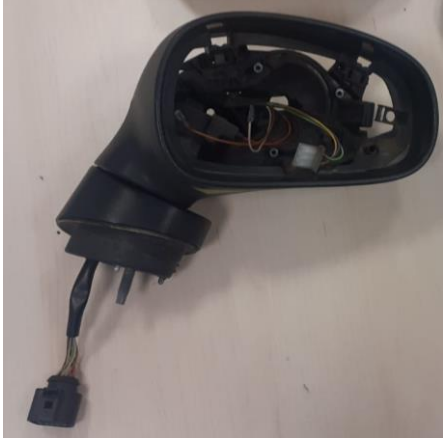
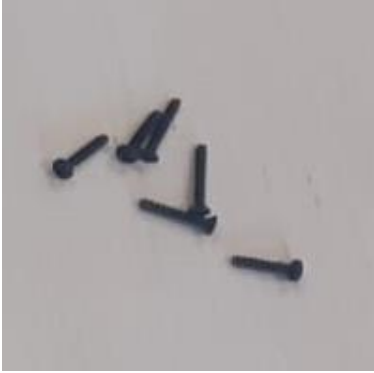
Figure 24: Exterior mirror level 3 disassembly process – SEAT Leon model II

Plastics	Non-ferrous metals + plastics + ferrous metals	Ferrous metals

Three different fractions are obtained in this part. The case is only made of plastics, and the screws are made of steel. However, three parts (main body, mirror adjustment system and the mirror) cannot be divided into further subparts even if they are manufactured with different fractions.

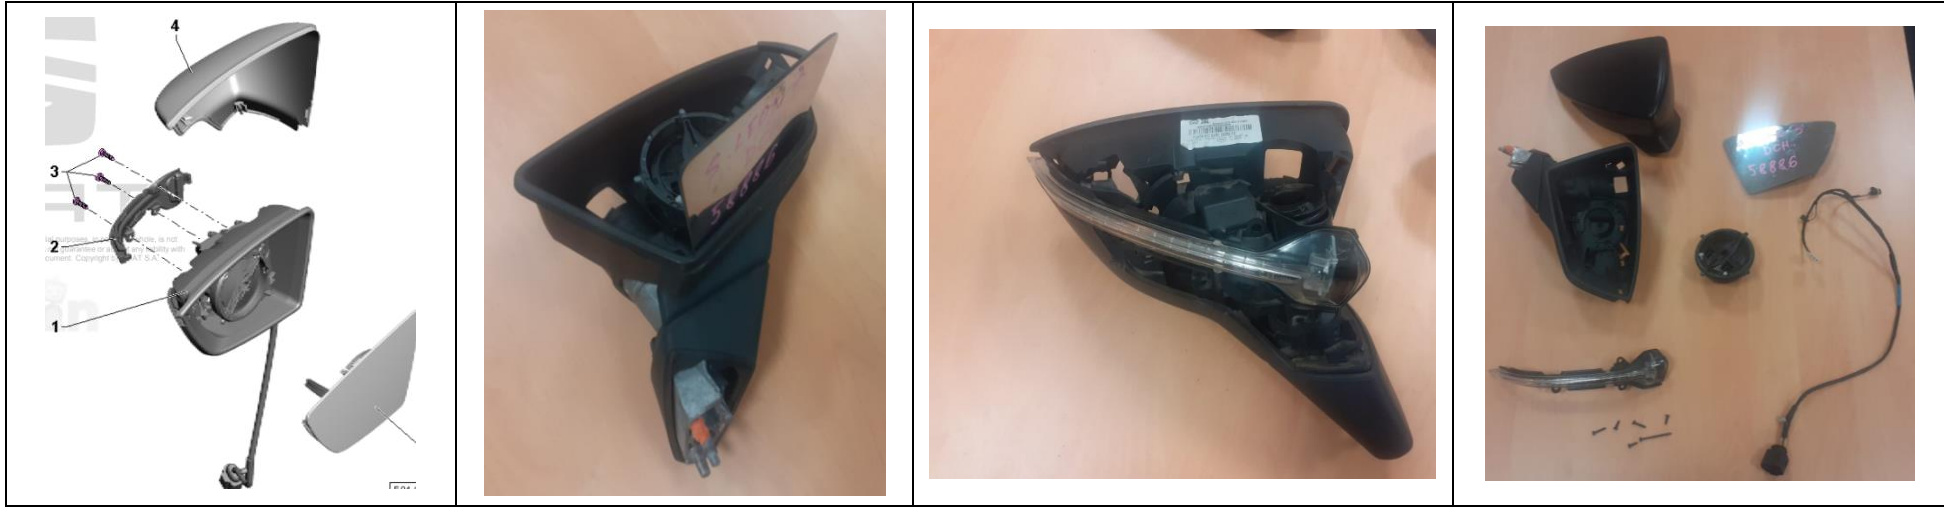
Figure 26: Exterior mirror level 2 disassembly process – SEAT Leon model III

Description	
Average time in real case	< 5 minutes
Difficulty level	High/Medium/Low
Required tools	Conventional: torx / flate screwdriver
Process description	The first step is to remove the mirror. It can be done by pulling it out because it is clipped. Next, the front cover can be separated from the main body by clicking it out. After that the LED can be disassembled by slacking three nuts. The engine that adjusts the mirror can now be disassembled by slacking the central screw.

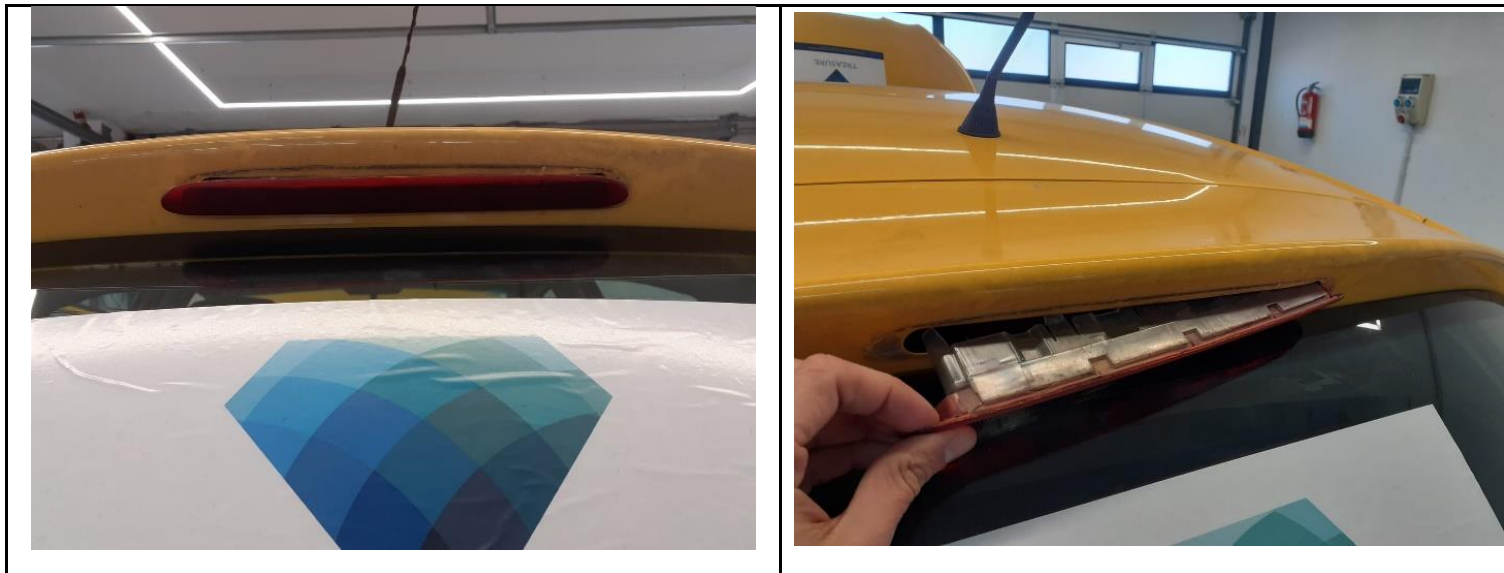
Figure 28: Additional brake lighting level 1 disassembly process – SEAT Leon model II

The first step is to unsettle the part to disassemble the rear additional braking system. It can be done using a flat screwdriver or even manually. Once the part is removed, the wiring needs to be unplugged. The image on the right shows the part removed from the car and the joining systems.

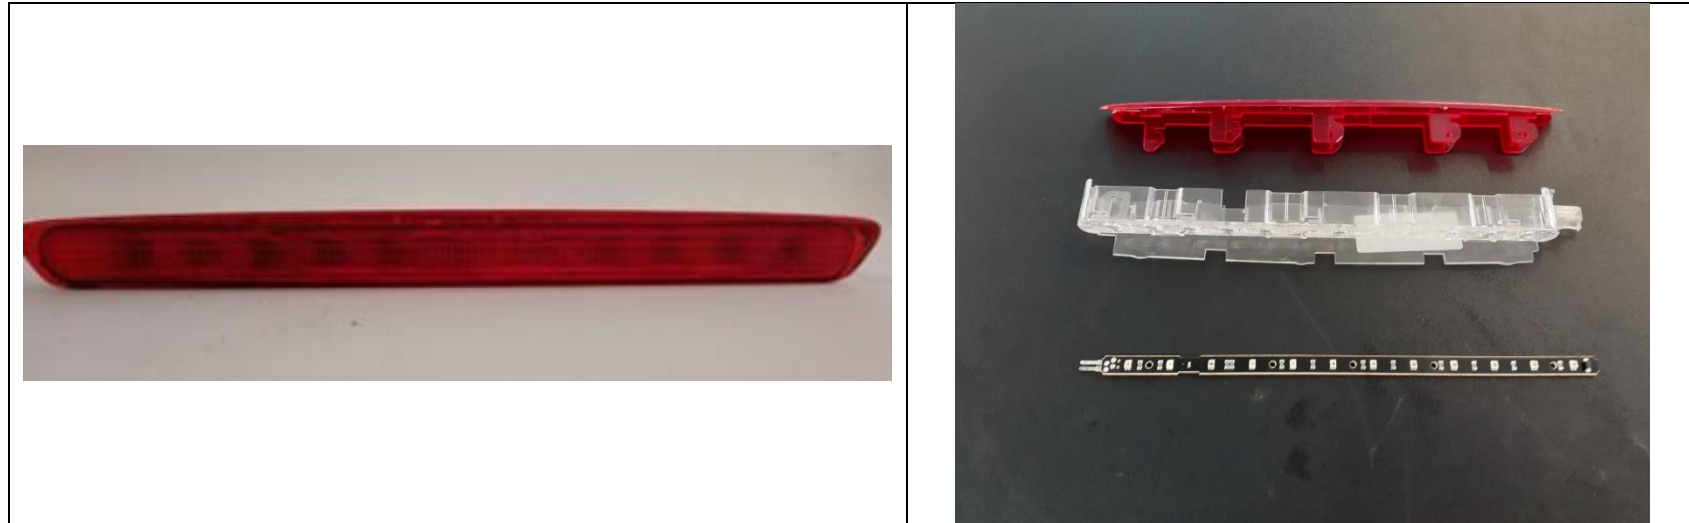
Figure 35: Additional brake lighting level 2 disassembly process – SEAT Ibiza model IV

Description	
Average time in real case	< 1 minute
Difficulty level	High/Medium/ Low
Required tools	Flat screwdriver
Process description	The main LED and electronic device are clipped with the light cover to facilitate a manual separation or using a plate screwdriver. Moreover, the metal clips joining the light to the body can also be removed using a flat screwdriver.

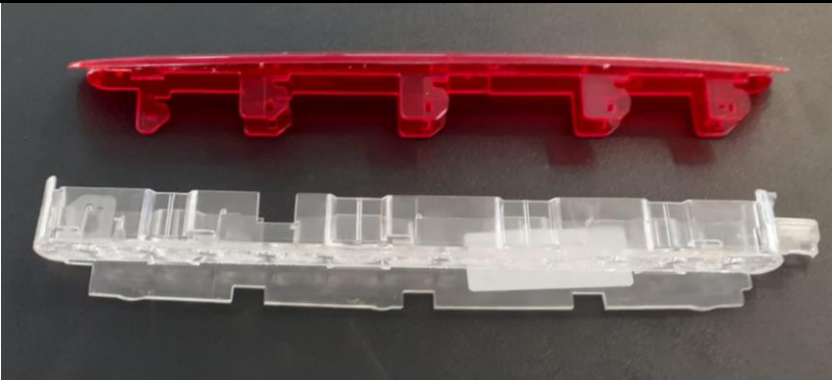
Figure 36: Additional brake lighting level 3 disassembly process – SEAT Leon model III

Plastics	Non-ferrous metals (excluding Al)

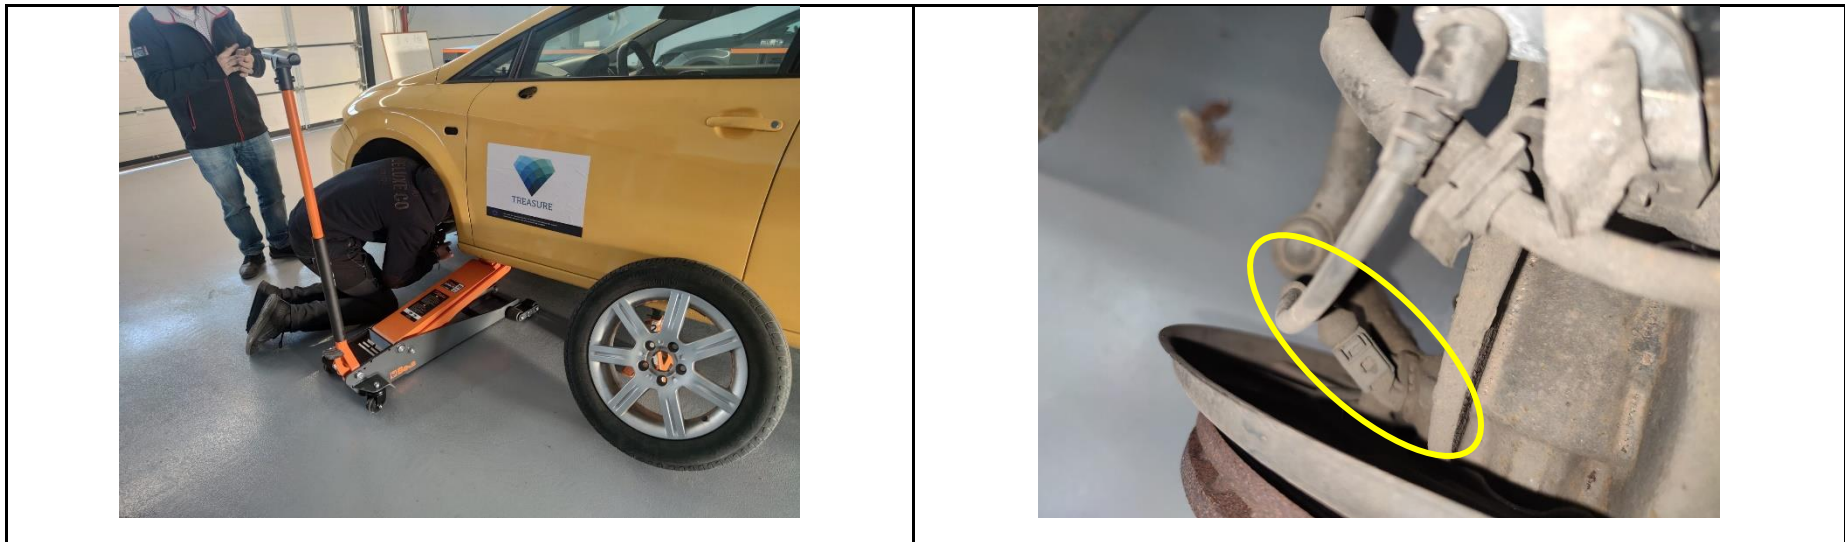
Figure 37: Speed sensor level 1 disassembly process – SEAT Leon model II

To disassemble the sensor, it is necessary to remove the wheel, as shown on the left image. The right image represents the sensor located next to the braking disc.
