TREASURE

D3.2: Report on disassemblability analysis

30/04/2022 (M11)

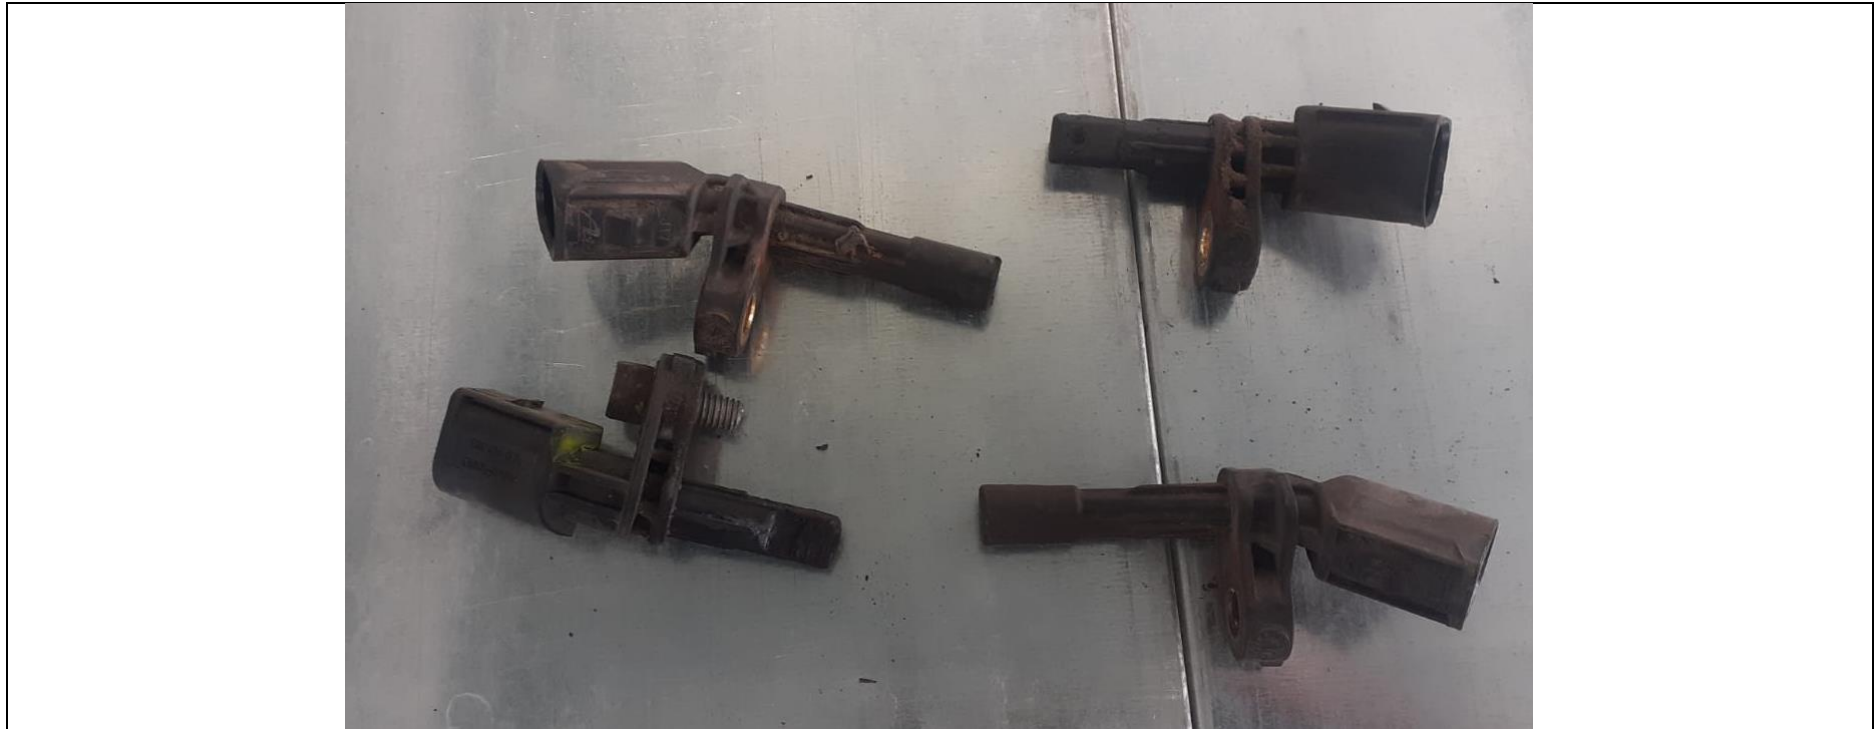
Figure 38: Speed sensor level 2-3 disassembly process – SEAT Leon model II

This part cannot be subdisassembled into smaller subparts, and as a consequence, the main fraction is a mixology of ferrous and non-ferrous metals plus plastics.

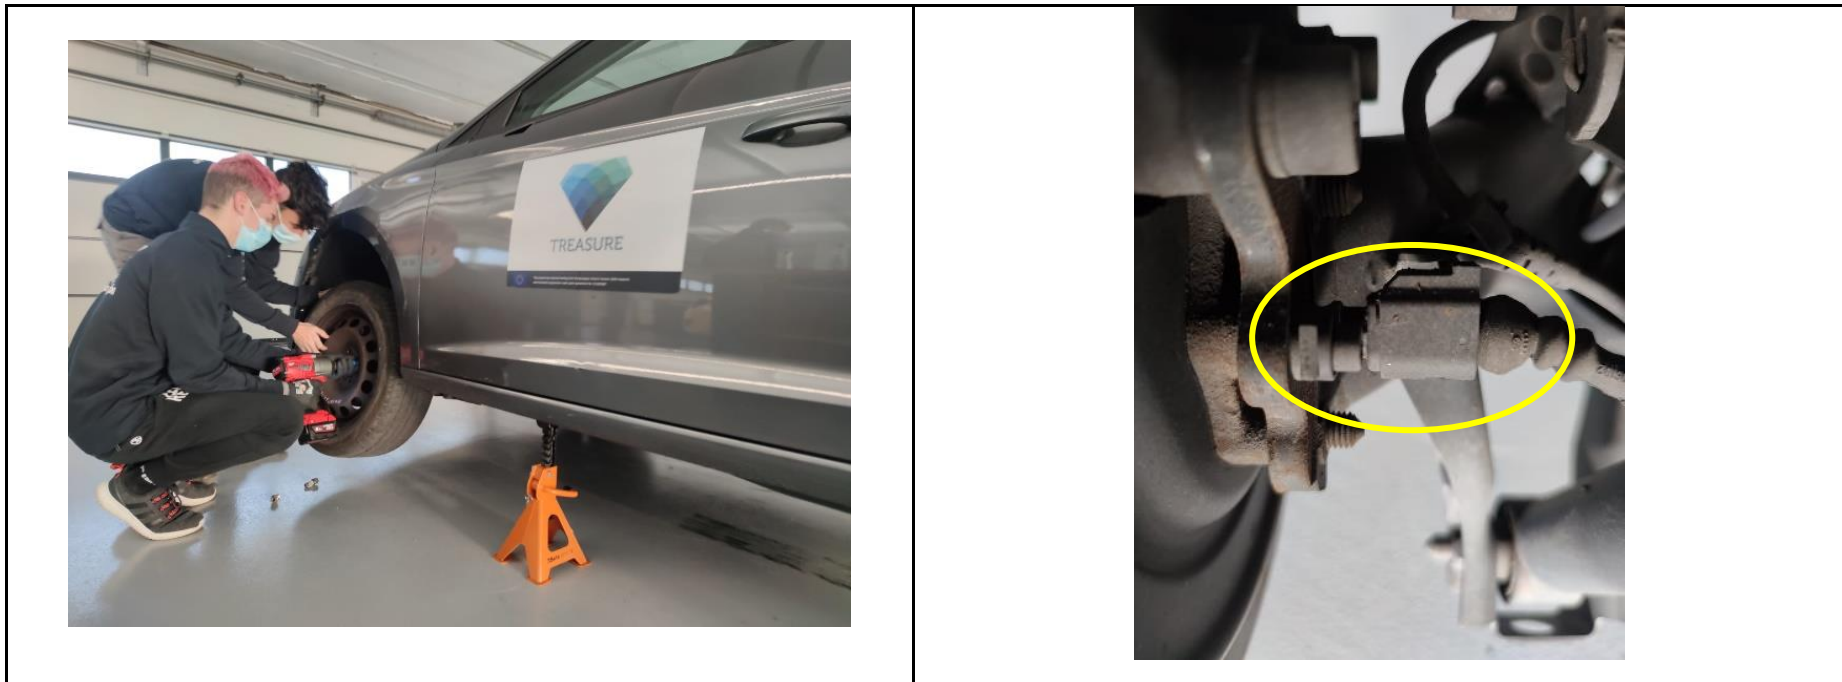
Figure 39: Speed sensor level 1 disassembly process – SEAT Leon model III

To disassemble the sensor, it is necessary to remove the wheel, as shown on the left image. The right image represents the sensor located next to the breaking disc.

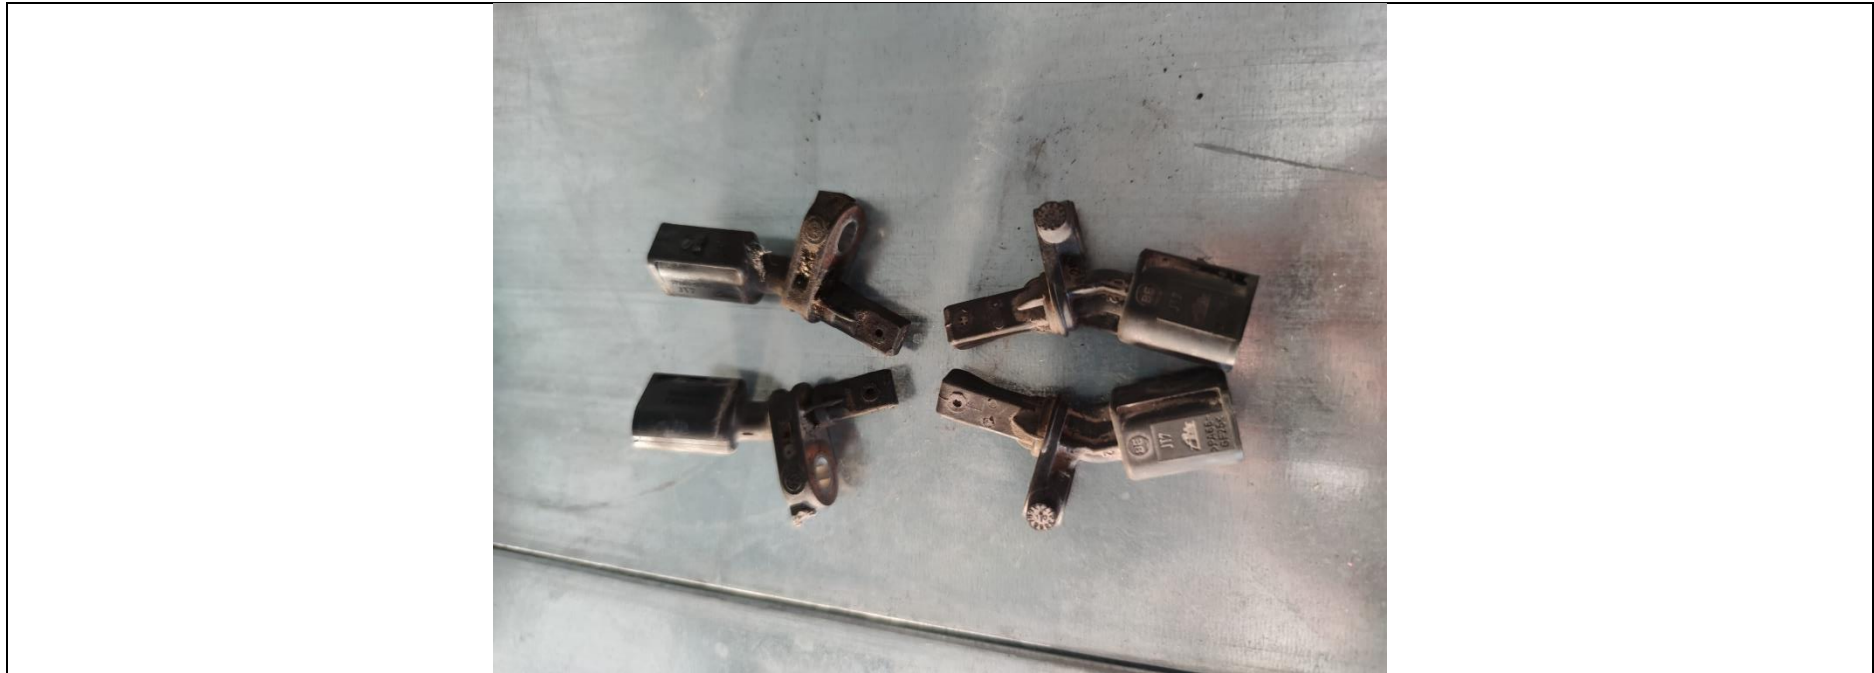
Figure 40: Speed sensor level 2-3 disassembly process – SEAT Leon model III

This part cannot be subdisassembled into smaller subparts, and as a consequence, the main fraction is a mixology of ferrous and non-ferrous metals plus plastics.

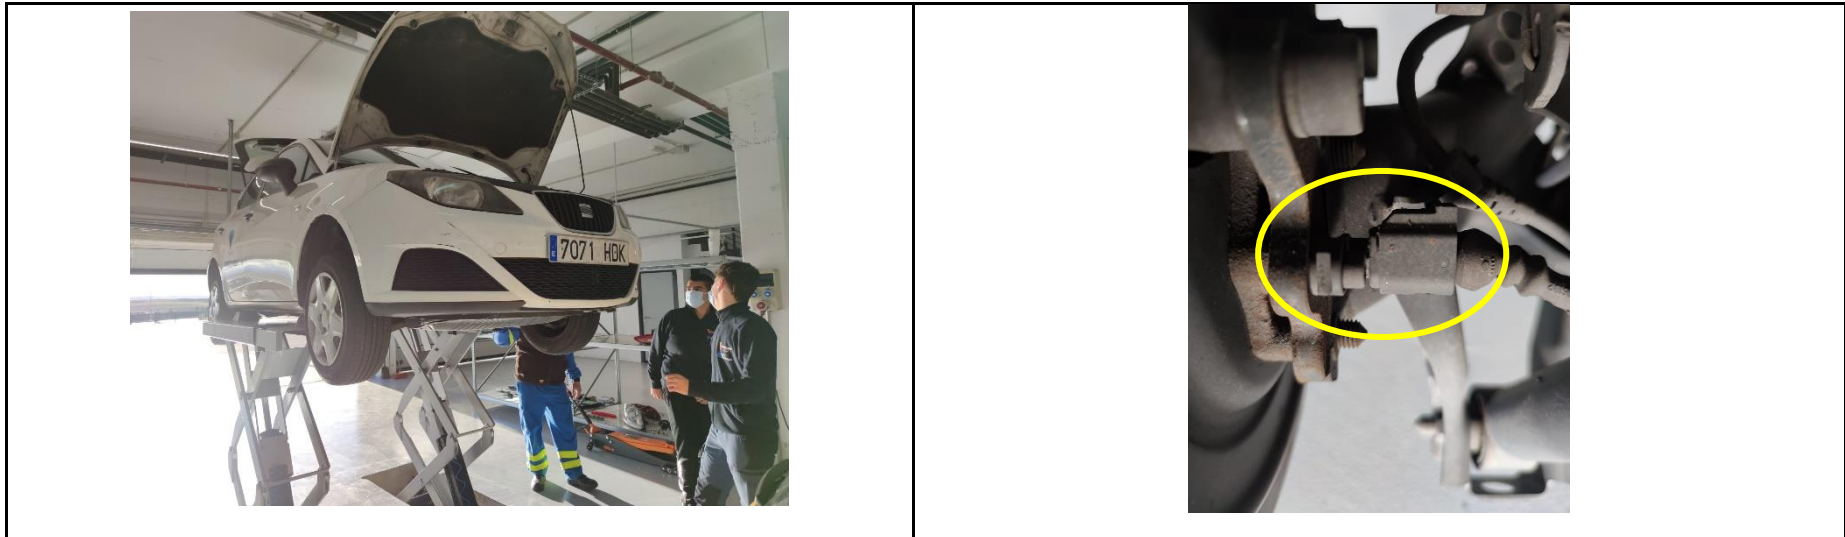
Figure 41: Speed sensor level 1 disassembly process – SEAT Ibiza model IV

To disassemble the sensor, it is necessary to remove the wheel, as shown on the left image. The right image represents the sensor located next to the breaking disc.

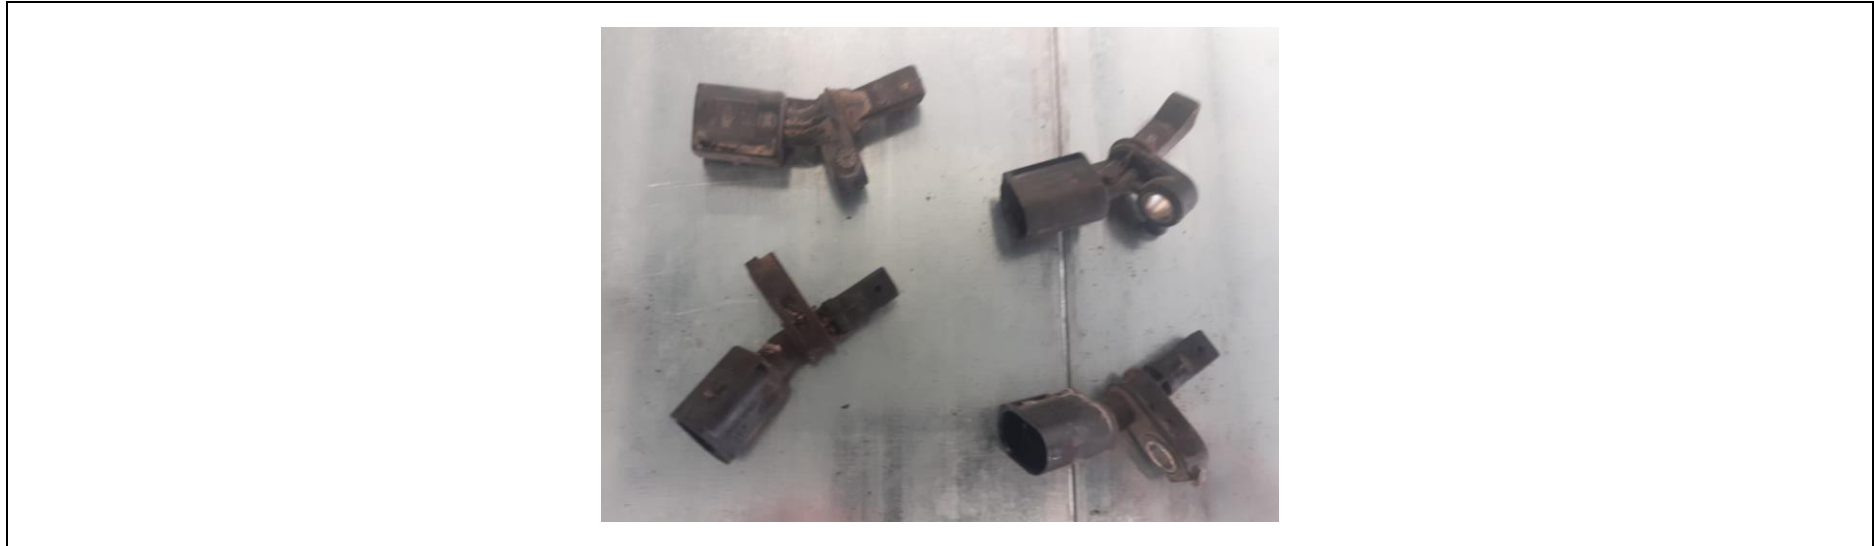
Figure 42: Speed sensor level 2-3 disassembly process – SEAT Ibiza model IV

This part cannot be subdisassembled into smaller subparts, so the main fraction is a mix of ferrous and non-ferrous metals plus plastics.

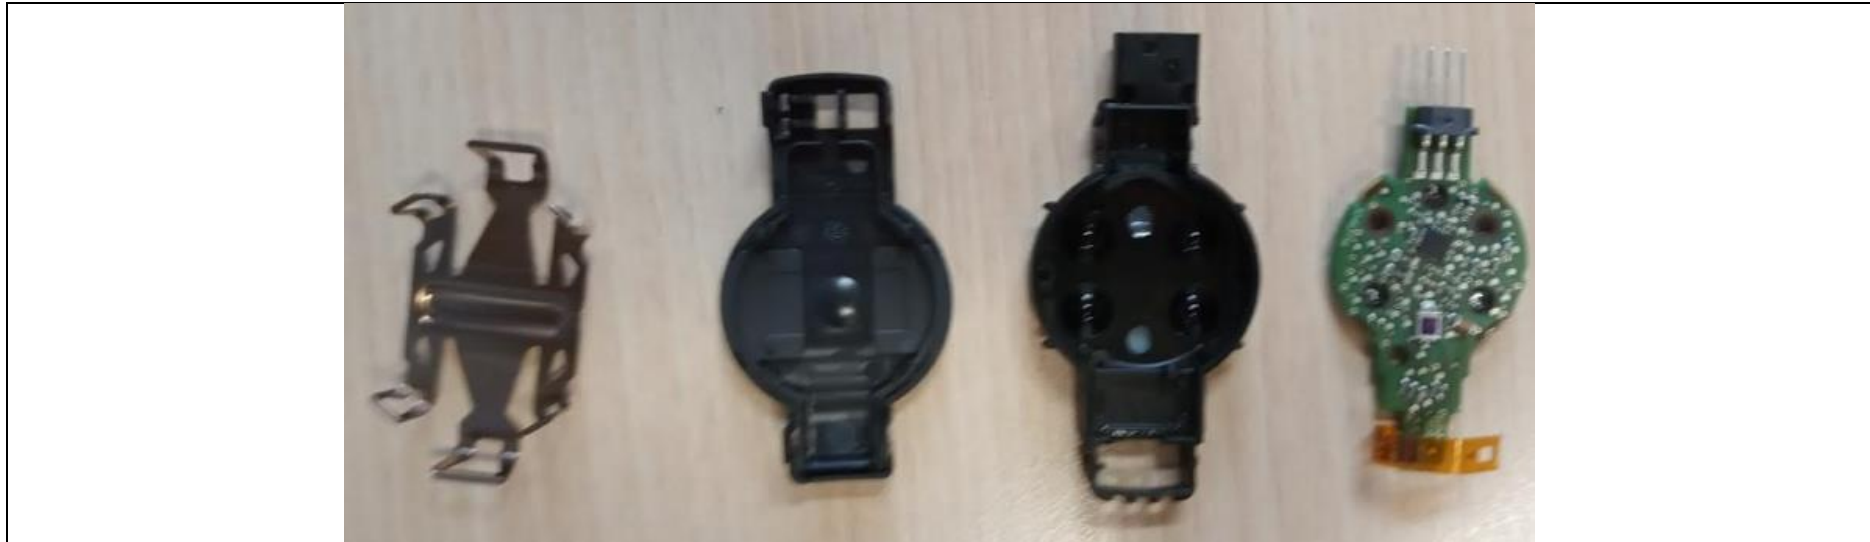
Figure 44: Rain sensor level 2 disassembly process – SEAT Leon model III

Description	
Average time in real case	< 1 minute
Difficulty level	High/Medium/ Low
Required tools	Flat screwdriver
Process description	Subparts are joined using clip systems. The first step is to unclip the metal clamp. Next, the plastic cover can be unclipped and separated. Finally, the electronic board is accessible and can be removed.

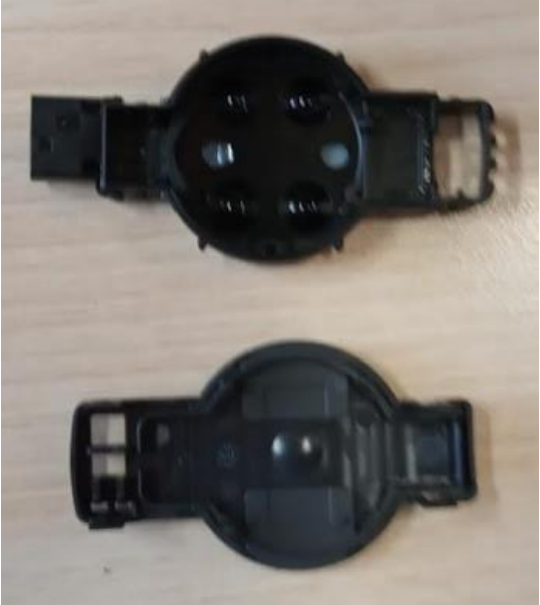
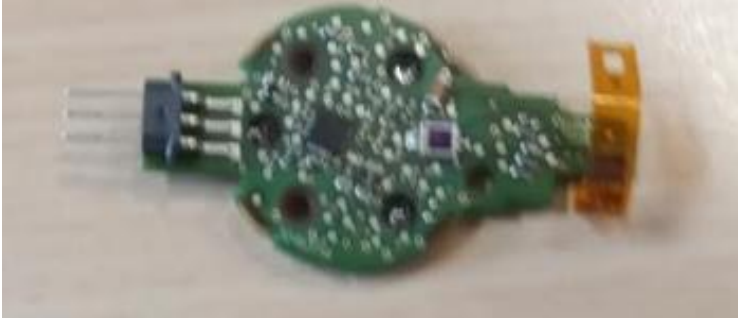
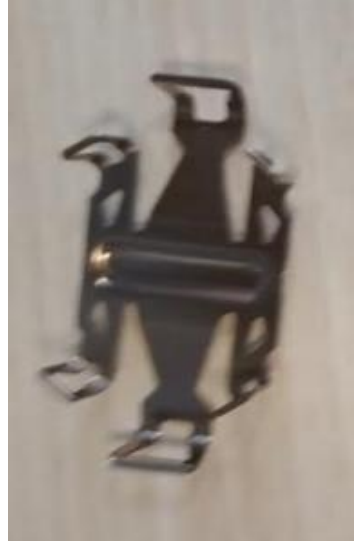
Figure 45: Rain sensor level 3 disassembly process – SEAT Leon model III

Plastics	Non-ferrous metals (excluding Al)	Ferrous metals

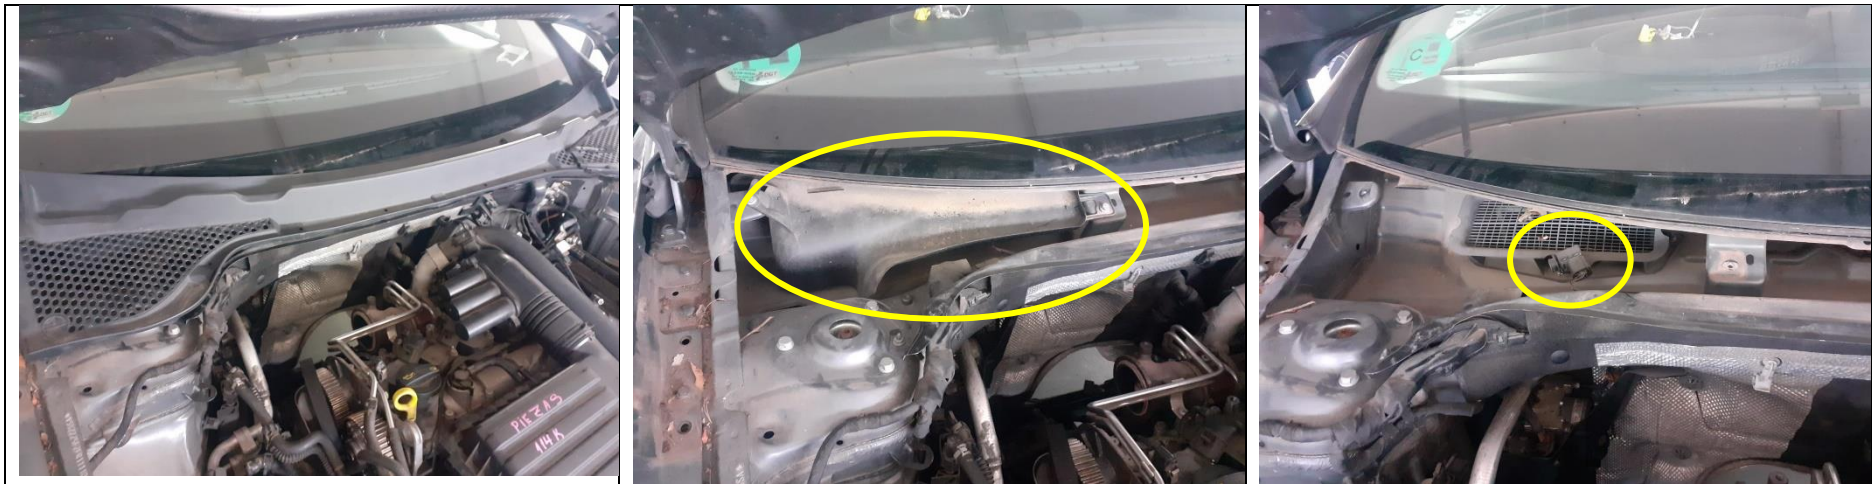
Figure 46: Air quality sensor level 1 disassembly process – SEAT Leon model III

The first step is to remove the plastic case to disassemble the sensor. This task can be done using a flat screwdriver. Next, the mirror needs to be unclipped by pulling it down. Its location is shown in the central image.

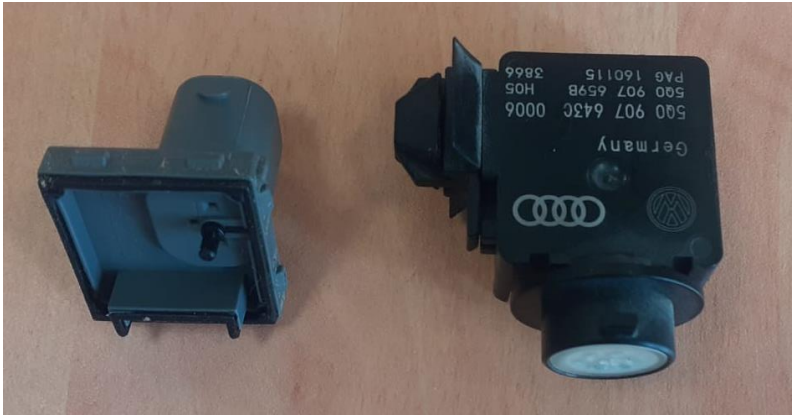
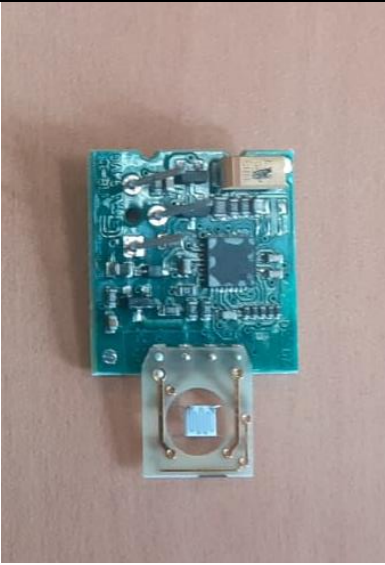
Figure 48: Air quality sensor level 3 disassembly process – SEAT Leon model III

Plastics	Non-ferrous metals (excluding Al)
